CASE STUDY

Redesign Extends Run Time for Hydrogen Chloride Compressor

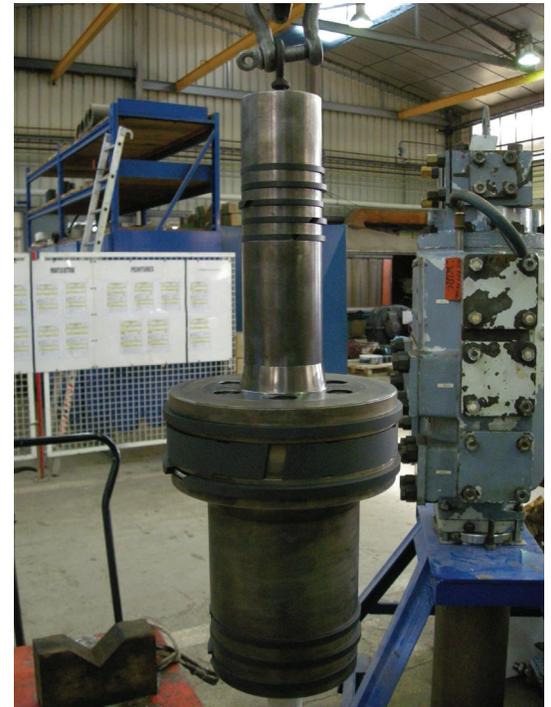
Three-stage, tandem piston

Cook Compression performed a thorough design review, recommending modifications to the piston and rider ring styles on all three stages of the tandem piston. Cook Compression also redesigned the pressure packing to include BTRR solid ring styles and changed all sealing ring materials to high-performance Cook TruTech™ 3330.
